# **AN ARCHAEOLOGICAL EVALUATION AT CAISTOR ST EDMUND CHURCHYARD, NORFOLK**

# **An Archaeological Evaluation at Caistor St Edmund Churyard, Norfolk**

NLA Reference CNF42347

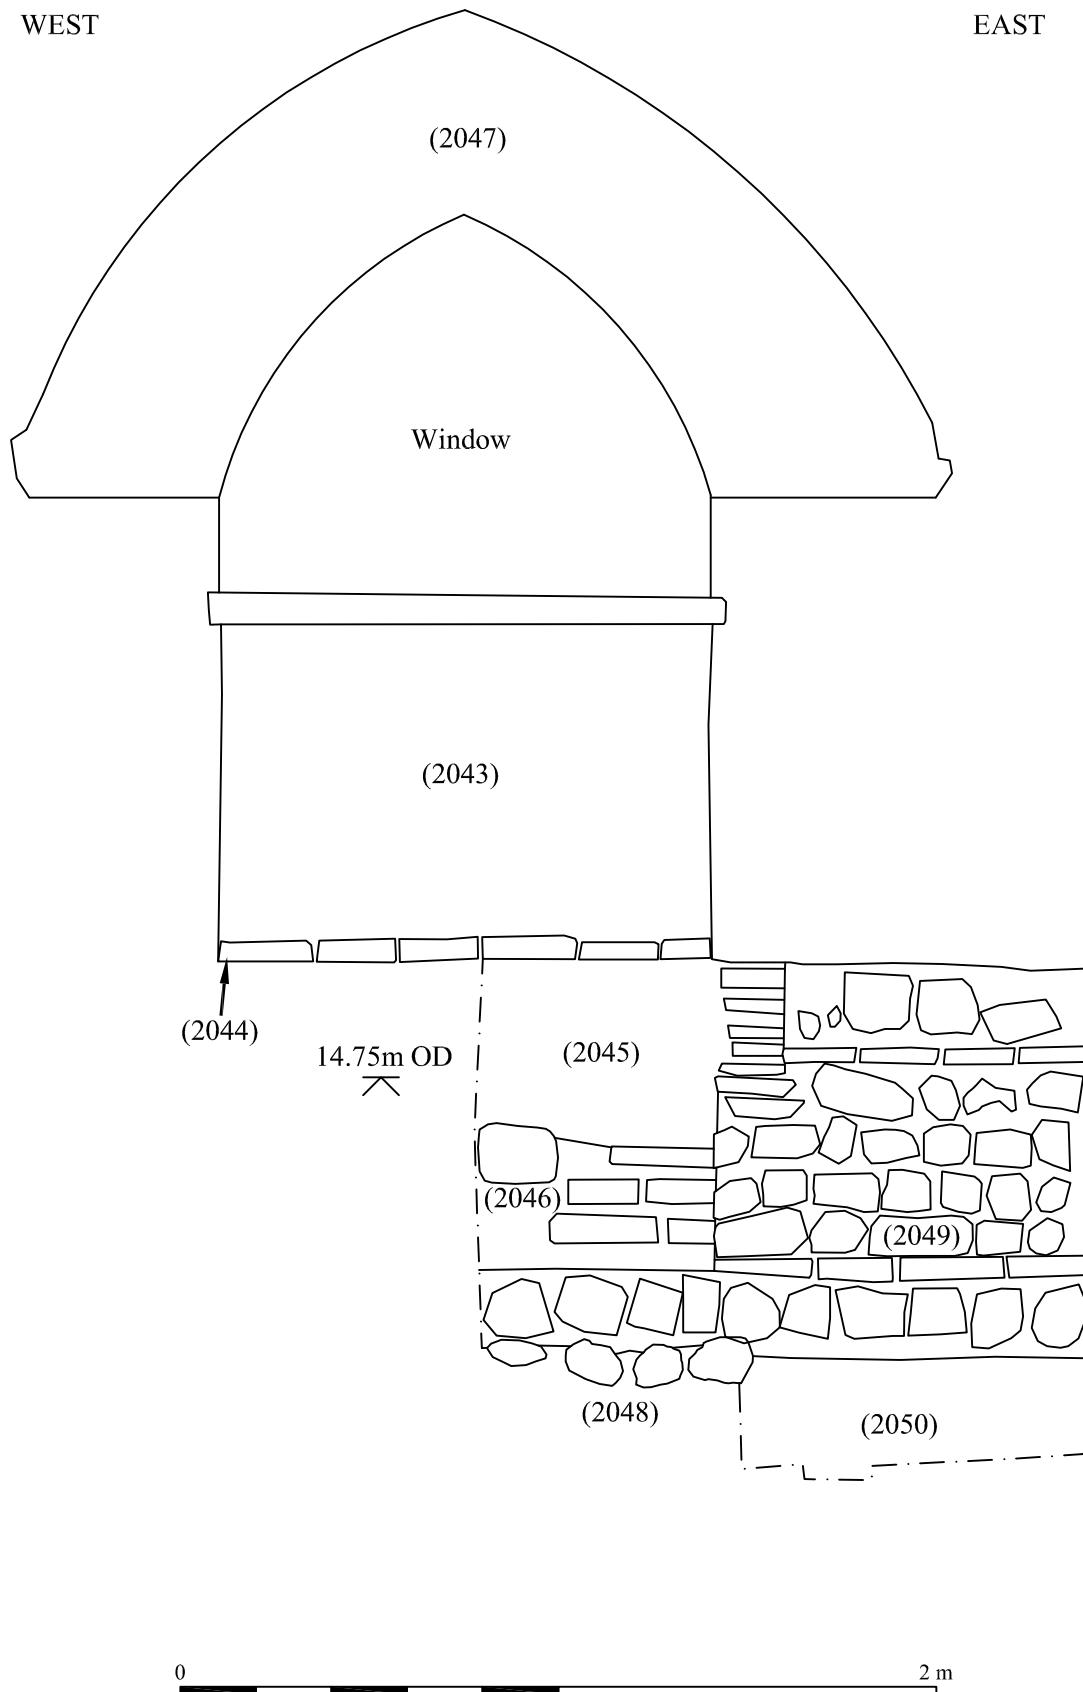
Figure 5. South facing elevation of Trench 1 showing blocked south doorway. Scale 1:20.

The two earliest masonry features recorded in Trench 1 were the nave wall and foundation (2049) and the foundations of an associated step (2048) (Figs 4 and 5). Below the level of the render the nave wall (2049) consisted of large, regular square or rectangular knapped flints laid in regular courses with single thickness tile string courses every c. 0.5m (Plate 2). In addition to the reused Roman tiles the knapped flints were almost certainly reused facing stones from the town walls. Despite single rather than multiple tile string courses being used in the nave wall it is very reminiscent of masonry around the south gate of the Roman town exposed by Atkinson in 1934 (Plate 3).

Reused Roman tile formed a square edge to the lowest parts of the side of the south doorway (Plate 2, Fig. 5). It is possible that this edge originally continued all round the doorway to form a plain round arch of reused Roman tile, as at the 7<sup>th</sup> century church at Brixworth, Northamptonshire (Eaton 2000).

As mentioned above, the extant gothic rendered brick arch (2047) of the south doorway (Fig. 5, Plate 5) is a 14<sup>th</sup> century alteration and its construction probably involved the removal of an 11<sup>th</sup> century Romanesque arch. During this process most of the reused Roman tiles that formed the sides of the doorway were chamfered and the threshold was raised by the insertion of a blocking c. 0.5m high (2046) also made of reused Roman tiles (Fig. 5). This indicates that the floor level of the nave was raised considerably during the 14<sup>th</sup> century alterations to the church. This was probably a reflection of raised ground levels within the churchyard, largely caused by burial activities.

The latest features recorded in Trench 1 were associated with the white mortar blocking or make-up (2045) placed within the south doorway prior to the laying of the pavement floor tiles (2044) visible protruding from underneath the brick blocking of the south doorway (2043) (Figs 4 and 5; Plate 5).

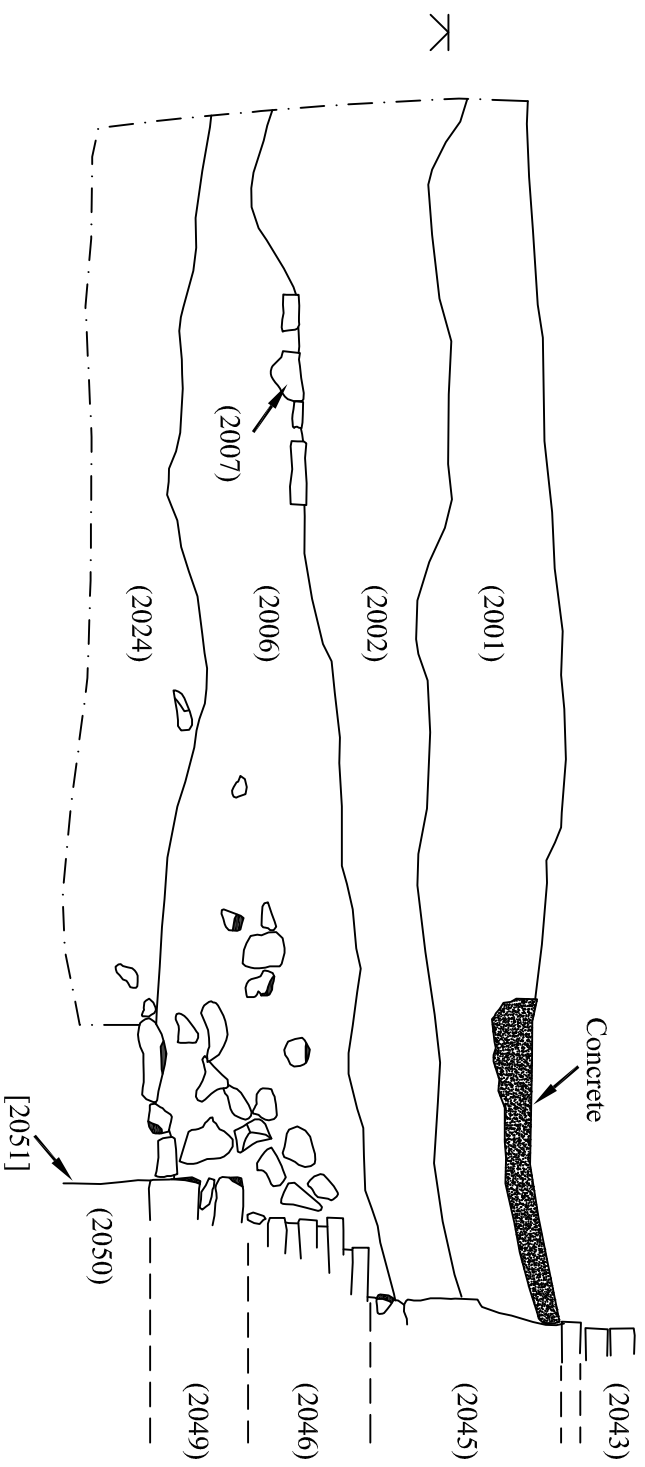
Figure 6. East Facing Section of Trench 1. Scale 1:20.

The upper horizon of (2024) lay at a level of 14.1m OD, 0.9m below the modern ground surface (Fig. 6). The upper 0.3m of this deposit was excavated. A hand auger sounding indicated that (2024) extended to a depth of 13.1m OD. Below this a further 0.45m of dark brown silty sand with lenses of clean yellow sand was recorded. Undisturbed 'natural' sands and gravels were not reached by the auger sounding which was halted by a large flint or similar obstruction. The lowest deposit recorded in the auger sounding may have been the fill of a cut feature of probable Roman date.

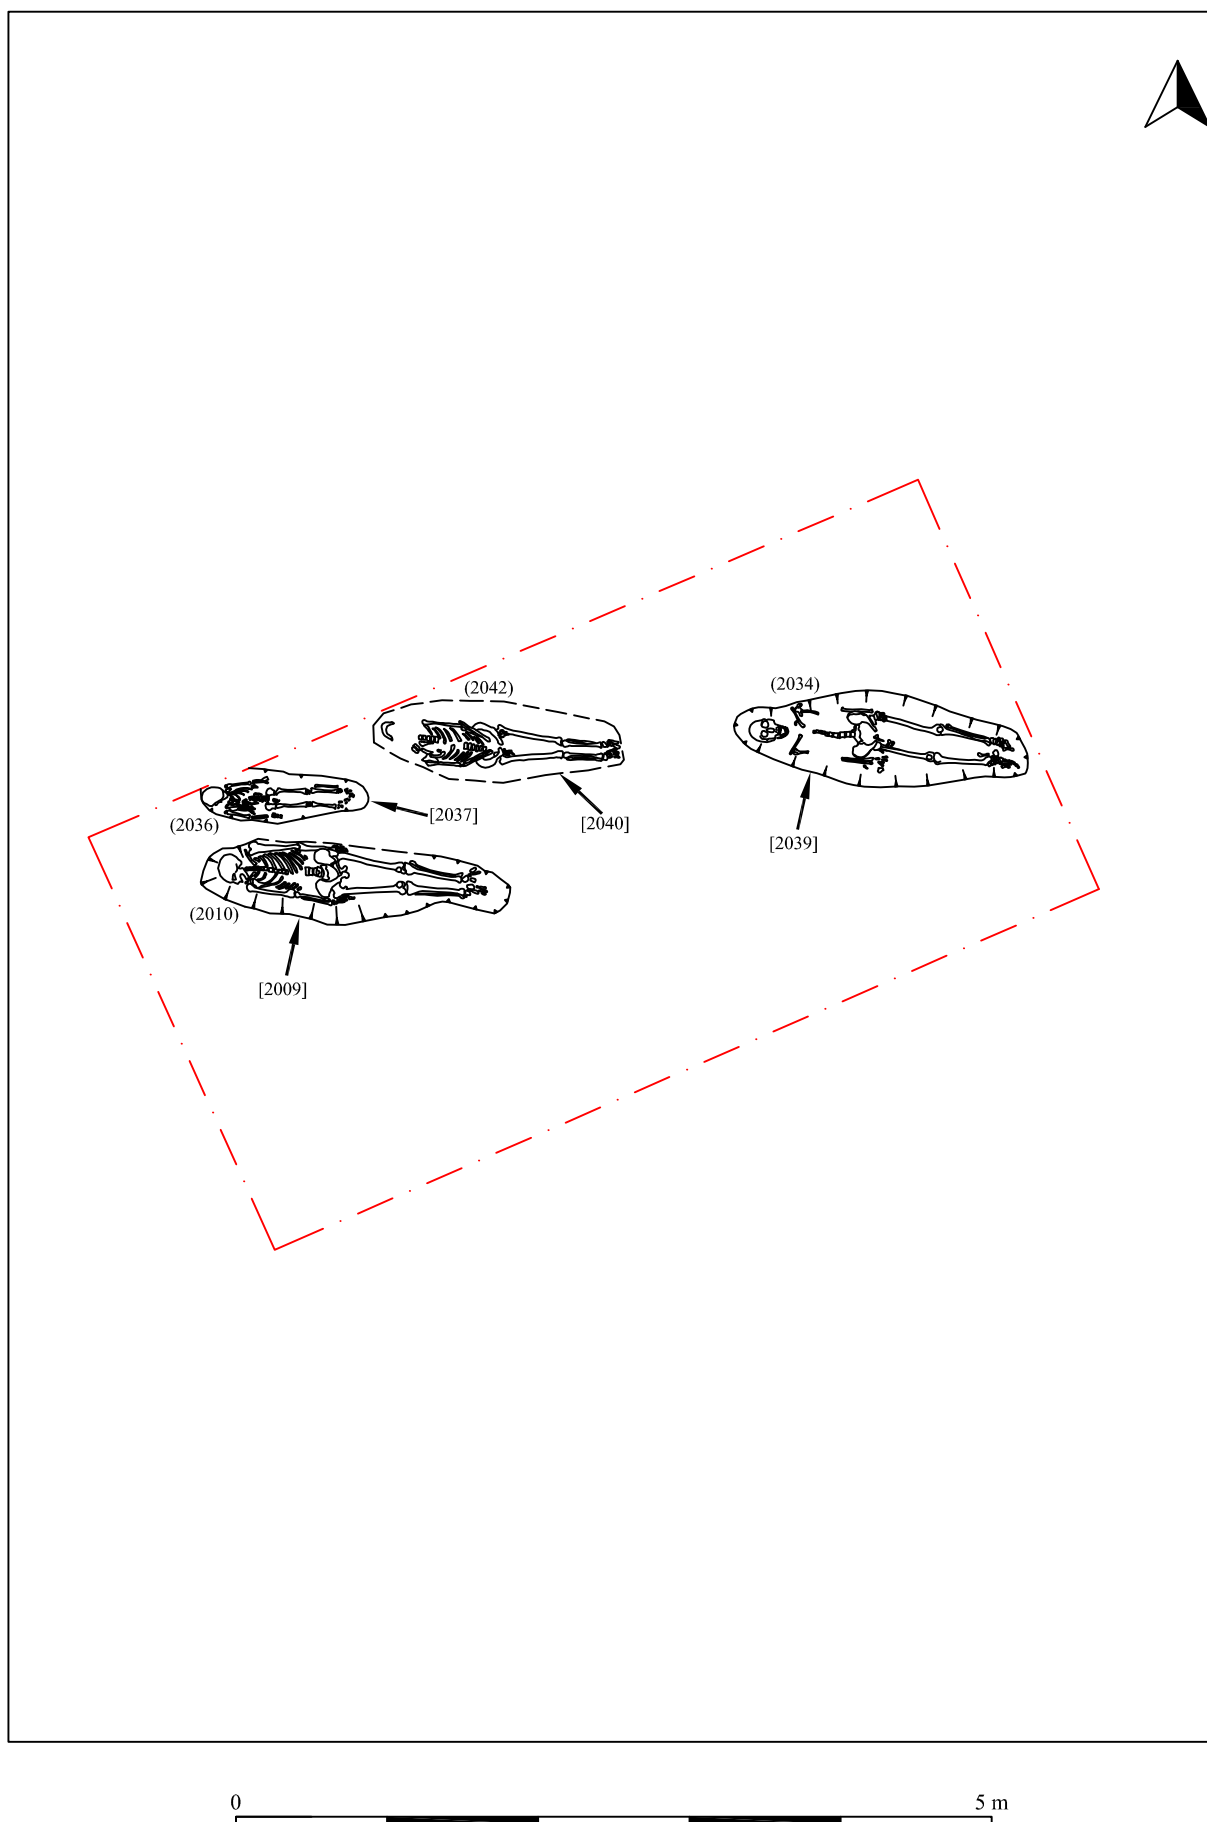
Figure 9. Medieval and post-medieval burials in Trench 2. Scale 1:50.

The lower subsoil deposit (2008) was also cut by the graves of three adults and one child (Fig. 9). The westernmost burial (2010) was probably post-medieval in date and lay in a narrow grave cut [2009] dug down into the upper surface of clay-rich upper fill of Roman pit [2056] (Plate 9). The somewhat constricted appearance of skeleton (2010) was due to it being, in all probability, a shroud burial. A possible shroud pin SF2155 was found close to the right hand/femur. The fill of this grave contained peg roof-tile of post-medieval date.

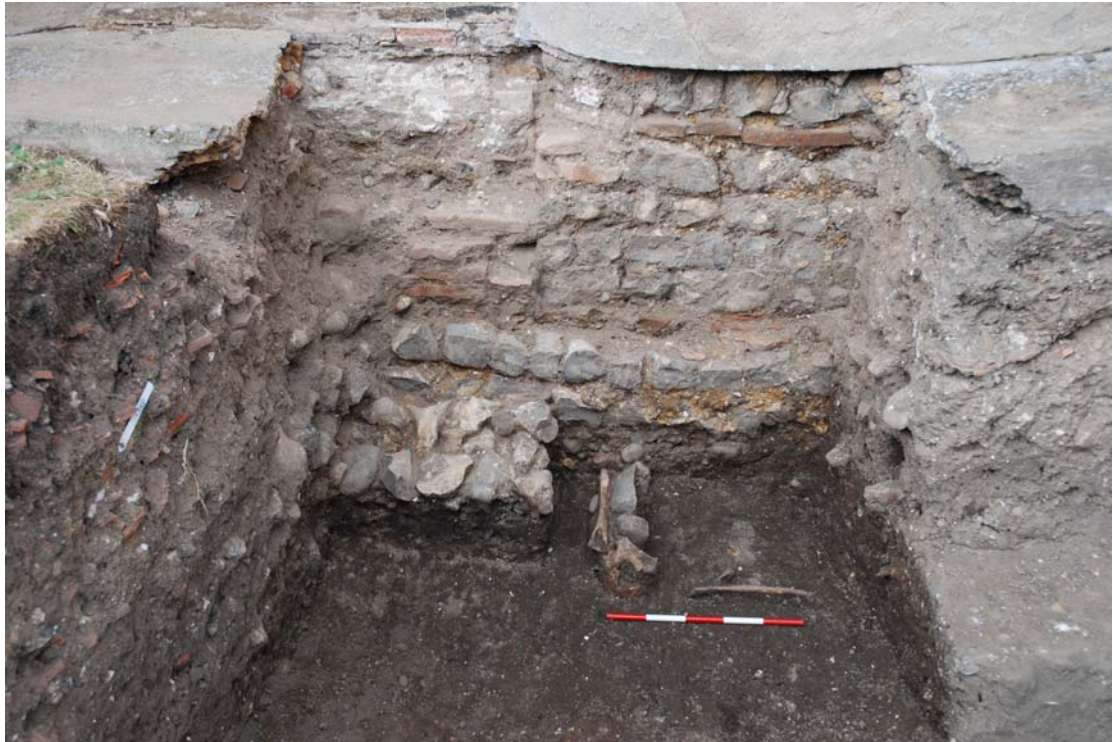
Plate 1                      Charnel material (2035)

The earliest feature in Trench 1 (2035) (Fig. 4; Plate 1) was a charnel deposit, a collection of disarticulated human remains including three complete adult skulls, fragments of a fourth adult skull, parts of a ?pelvis, a femur and one other long limb bone. The placement of these remains in a pile on top of each other indicates they must have been contained within a pit ([2054]), although as mentioned above no cut could be seen. It is likely that the pit was either cut by or was a very near contemporary of the foundation cut for the nave wall [2051]. The likely date and significance of the charnel deposit (2035) is discussed below.

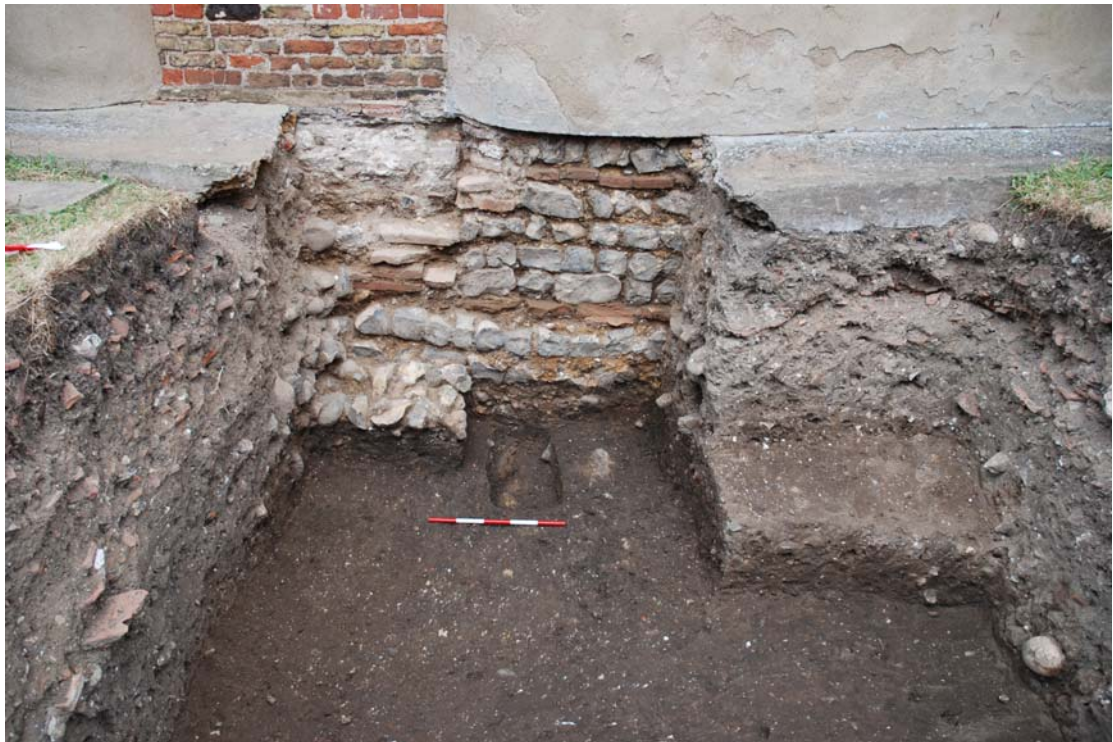
Plate 2                      South wall of nave (2049), showing tile string courses and offset foundations

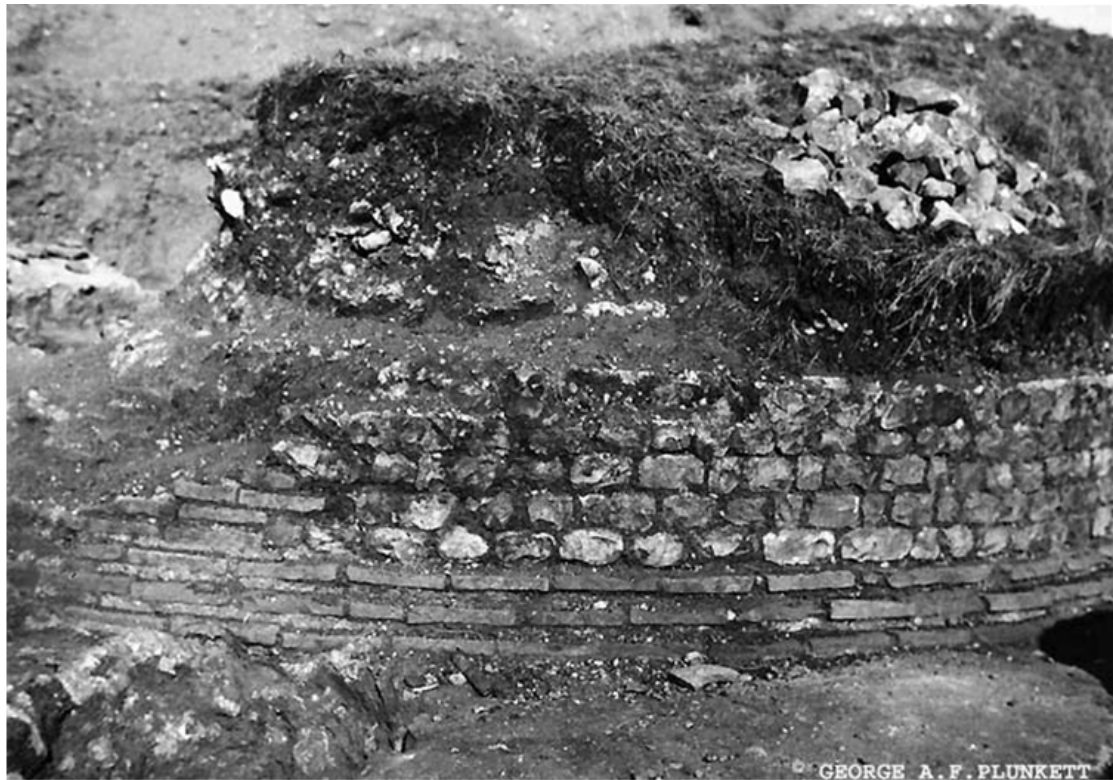
Plate 3      Masonry exposed during Atkinson's excavations of the south gate in 1934. Photograph by the late George Plunkett

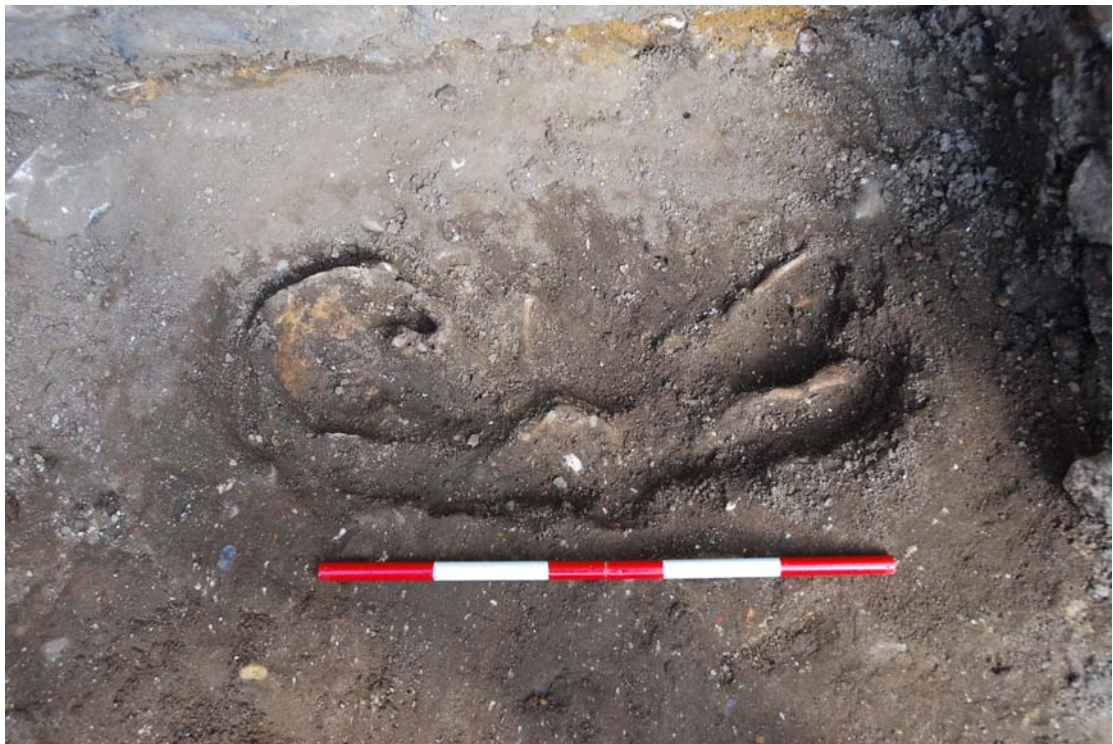
Plate 4      Child burial (2019) adjacent to the nave wall

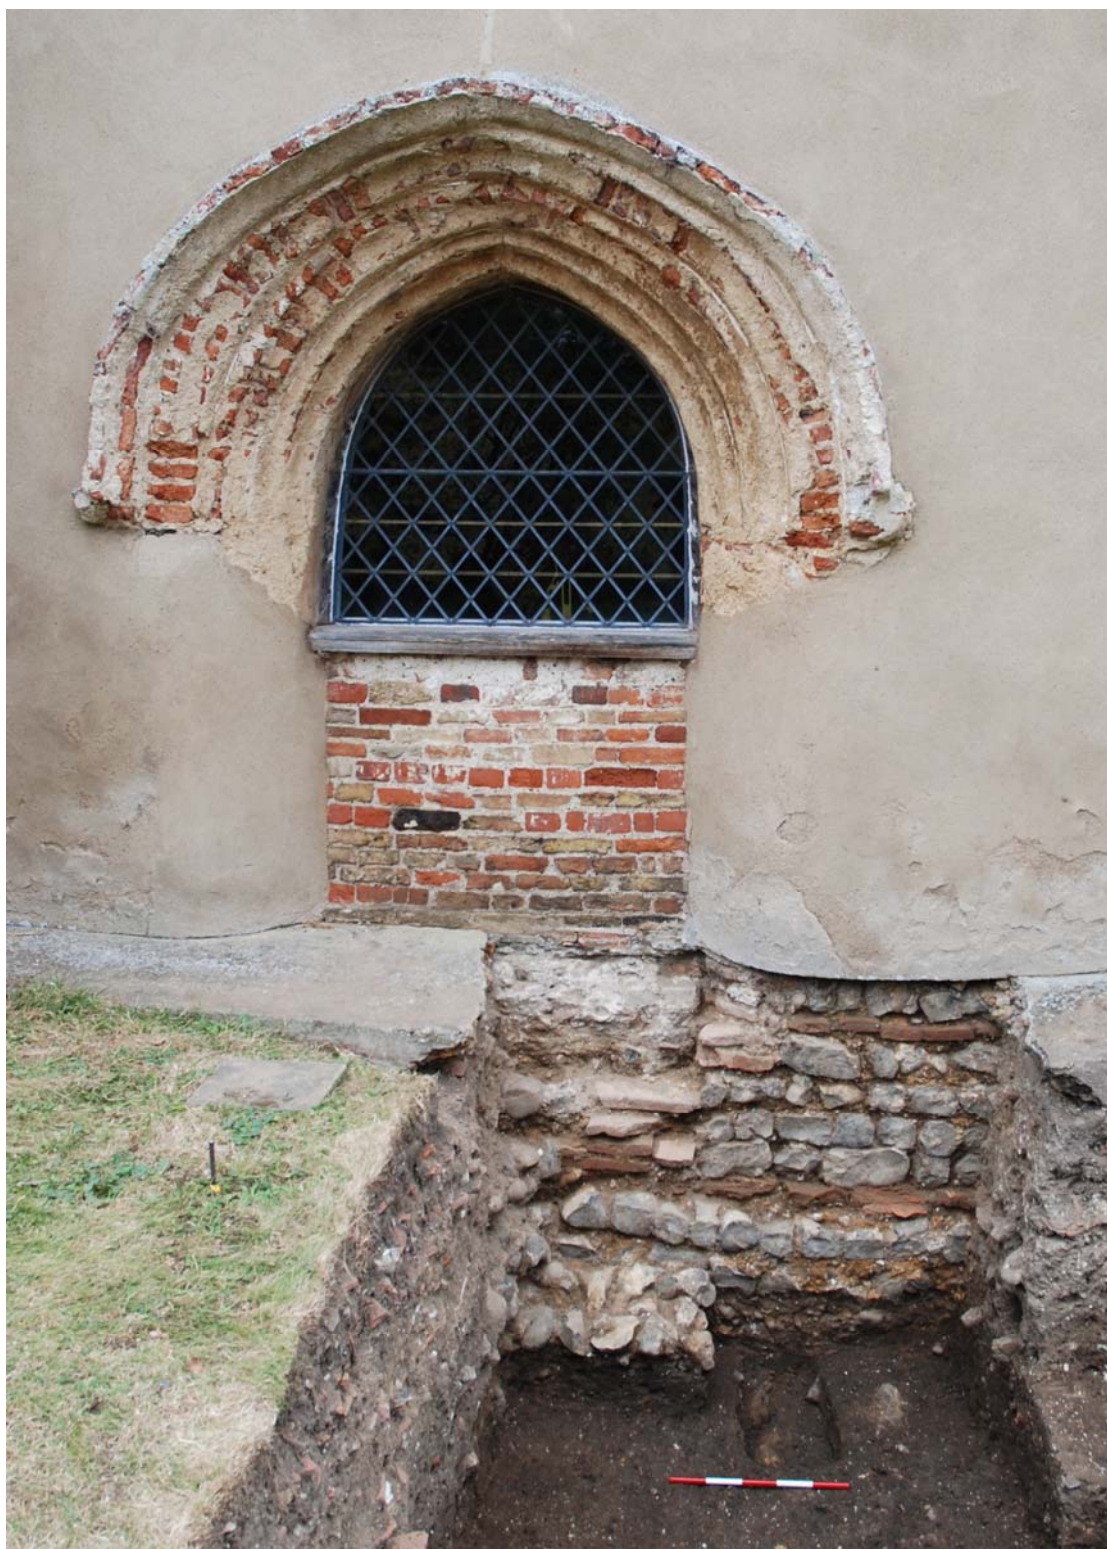
Plate 5

The south doorway of the nave with the south-facing section of Trench 1 below

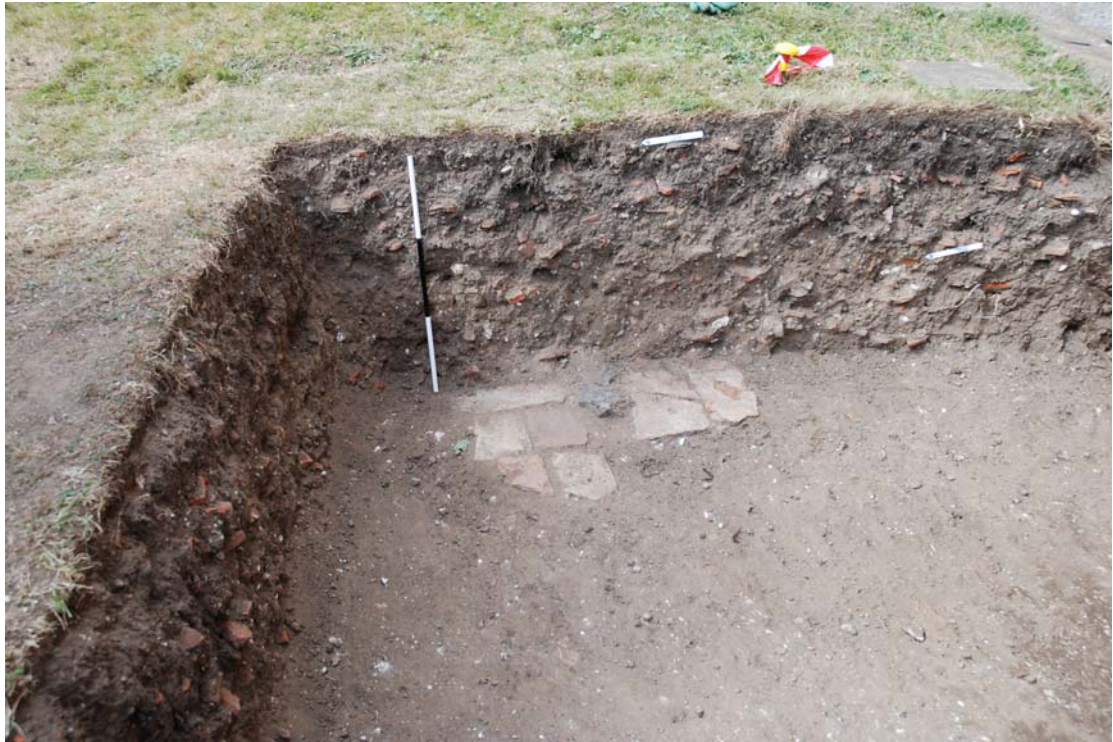
Plate 6      Tile path (2007)

Two features were visible on the surface of the upper graveyard soil (2006). A fragmentary path (2007) was seen on the western side of the trench. It was largely made of tile, some of it reused Roman material, with a central band of large unmodified flints, set into an irregular bed of yellow sand. It was probably part of a path that led to the south door and was probably of post-medieval date. It may have continued eastwards, lenses of yellow sand and mortar (2012) being recorded towards the centre of the trench.

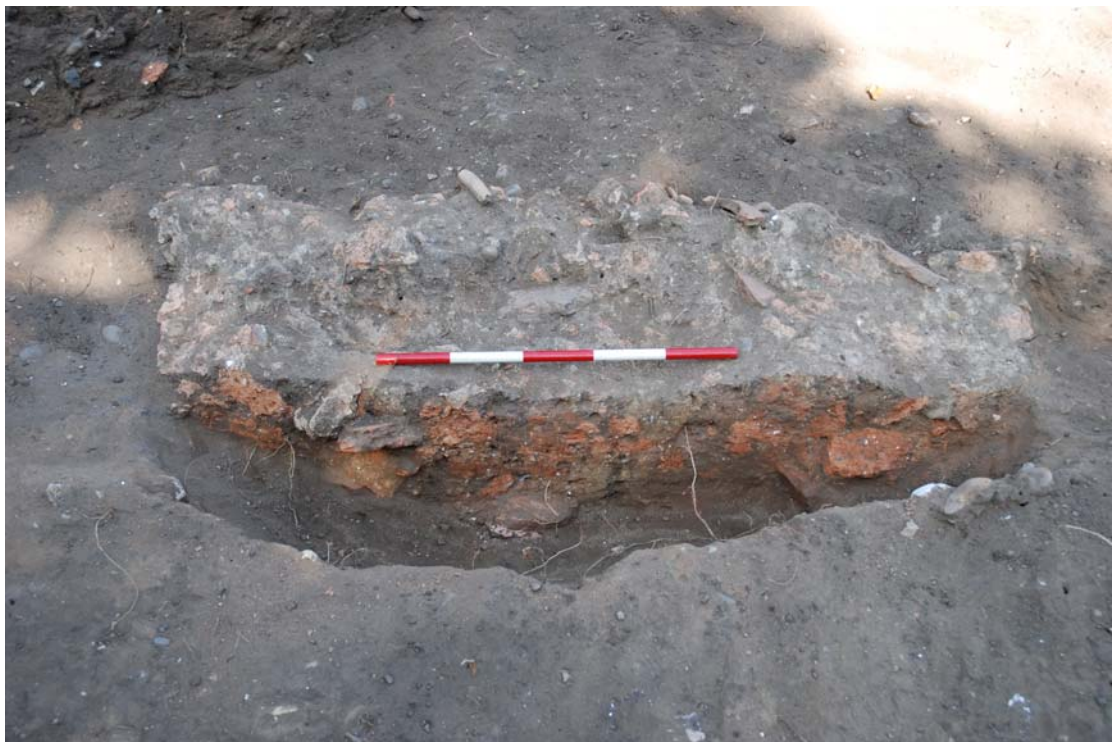
Plate 7      Roman pit [2056], filled by clay & tile debris (2026)

Both the gully [2060] and pit [2056] were cut by a larger east-to-west aligned linear feature [2053]. This ditch or gully was 1.1m wide and between 0.25 and 0.4m deep. After some initial silting and minor disturbance of the ditch base evidenced by deposits (2058)=(2061) it was filled, possibly deliberately, with grey-brown silty sands (2052)=(2057), which contained mid-late Roman pottery. The western unexcavated part of this deposit contained a dump of large unmodified flints (Fig 8), which may have been debris from a nearby Roman masonry building.

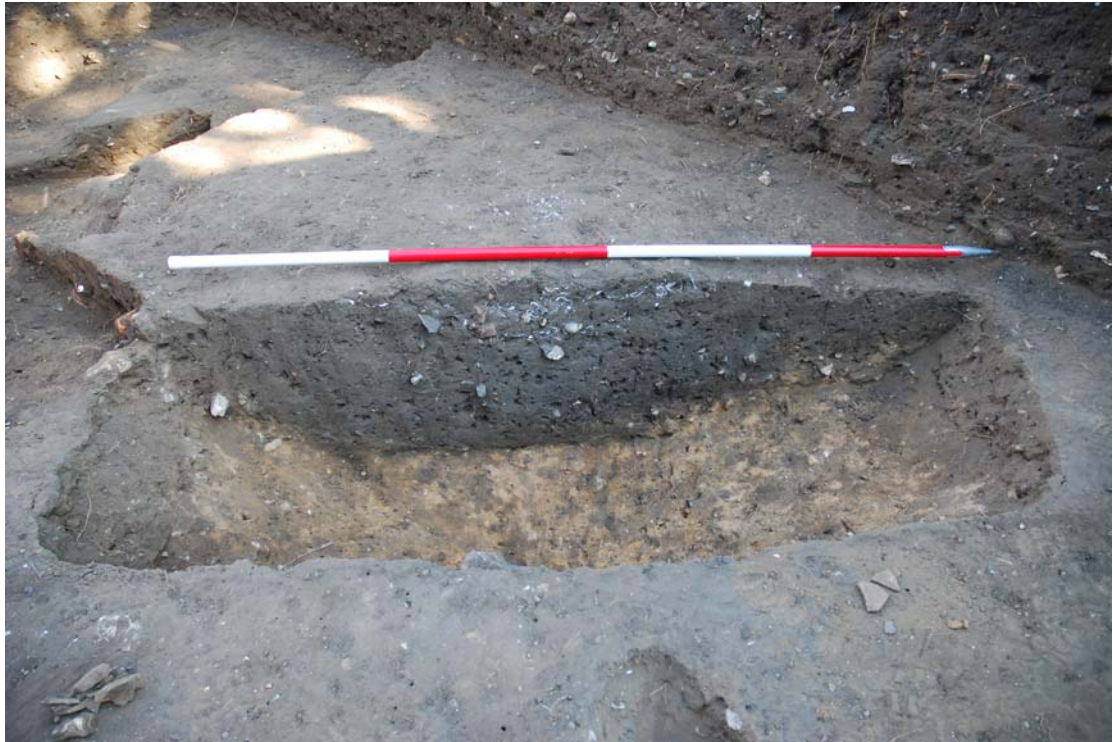
Plate 8      Roman Pit [2032]

The earlier Roman features were all sealed by a subsoil-like build-up (2008) which in turn was cut by a large sub-circular rubbish pit [2032] (Fig. 8, Plate 8). The dark silty fill (2028) of pit [2032] contained much oyster and mussel shell in addition to animal bone and pottery of mid to late Roman date (3<sup>rd</sup>-4<sup>th</sup> century). The subsoil-like build-up (2008) contained a large mixed assemblage of primarily mid - late Roman pottery, as well as (probably intrusive) Saxon and Medieval material.

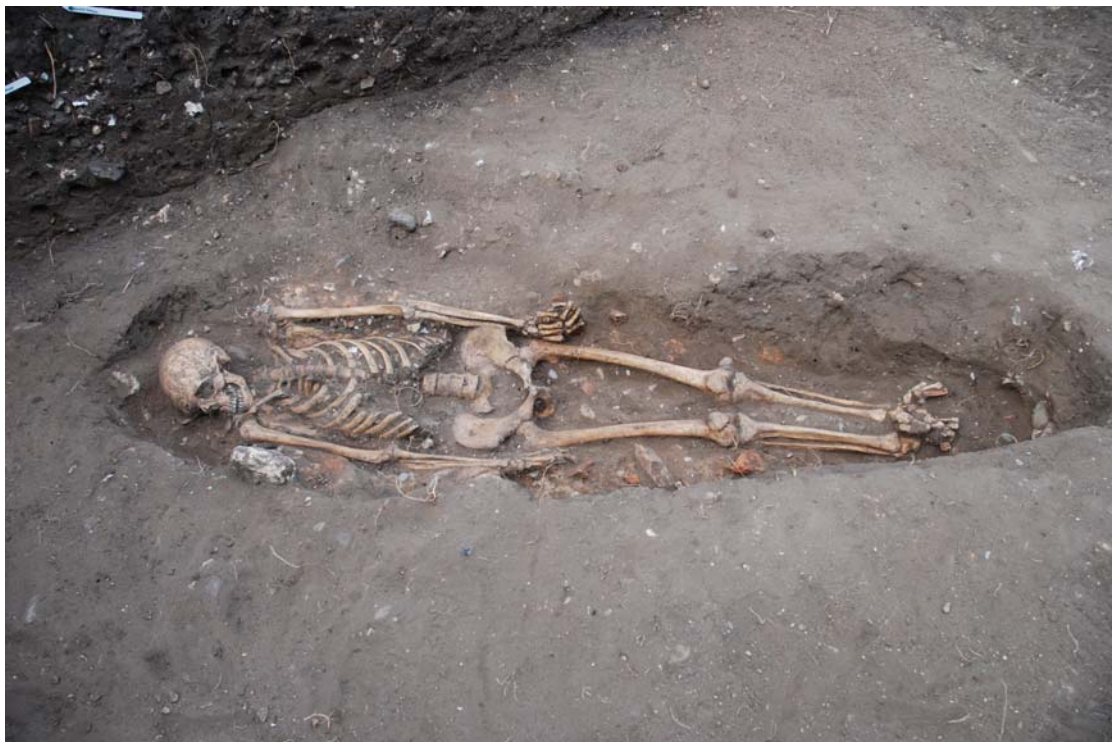
Plate 9      Skeleton (2010)

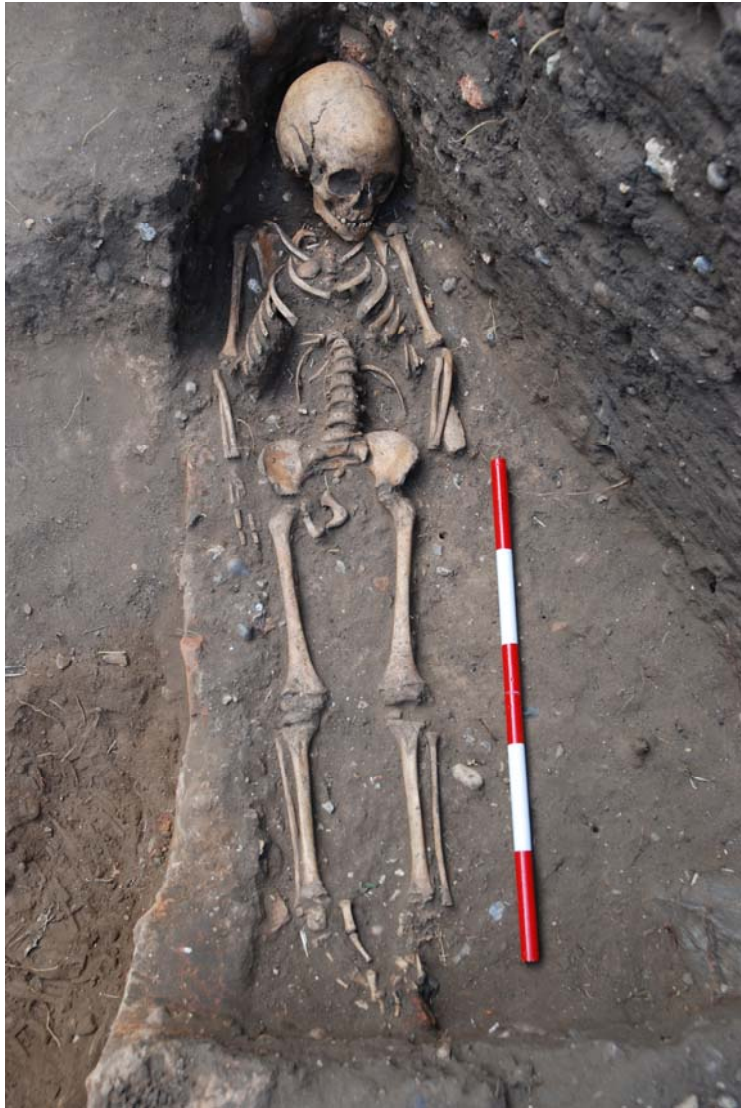
Plate 10      Skeleton (2036)

The other three burials excavated in Trench 2 were all somewhat earlier in date being medieval or early post-medieval. Unusually the child burial in Trench 2 (2036) (Plate 10) was also a shroud burial complete with shroud pin SF2235. The two other adult skeletons (2034) and (2042) were not as well preserved as (2010). Skeleton (2042) showed signs of damage from tree roots and skeleton (2034) was missing most of its upper arms and ribs due to post-depositional damage.
